THE DIVERSION SCHEME

Gates, stopbanks, channels and floodways

The Lower Wairarapa valley Development scheme is one of the largest and most complex flood management systems in New Zealand. nearly 30 years after its completion there are still challenges in the management of the scheme

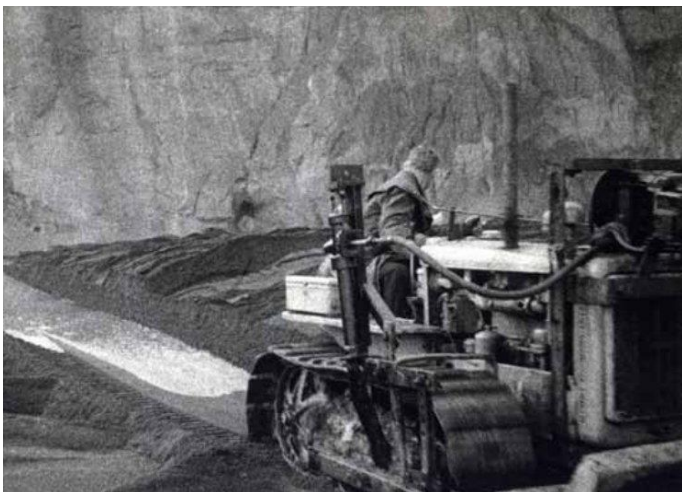
For the first time the mouth of the Ruamahunga River is opened mechanically circa 1940s. Keith McMaster is at the helm. Today, the opening is made using the combination of a digger and bulldozer. Photograph private collection

The Ruamahunga River flows into the sea at Palliser Bay through the Lake Onoke Spit. The mouth of the Ruamahunga River is called the lake opening. The natural opening generally migrates towards the eastern end of the sand bar and when this happens the flow out to sea is reduced considerably. Under the scheme the opening is sited in line with Lake Ferry road to enable quicker drainage of the river.

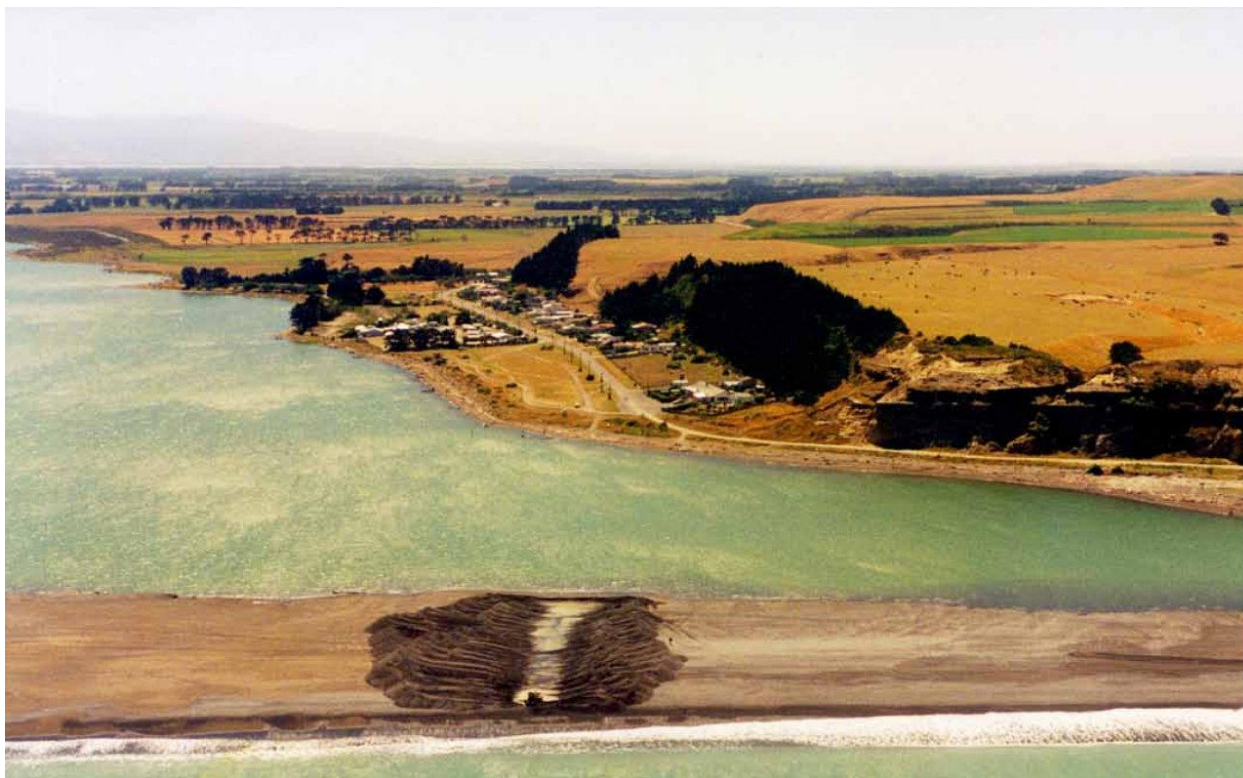
Opening the Ruamahunga River mouth opposite the Lake Ferry Inn (now Lake Ferry Hotel), 1997. Photograph GWRC

Typically, between January and May the mouth gets blocked when there is low river flow, combined with large southerly swells in Palliser Bay. However, it can get blocked at other times, too. In an extreme year, the mouth could be blocked as many as 18 times but on average there are between six and eight blockages a year.

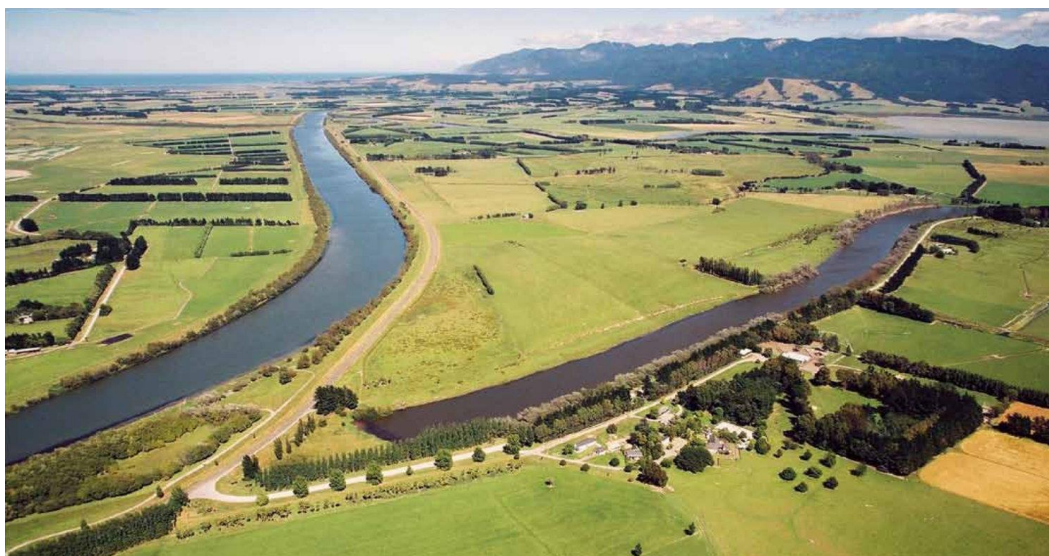
The Ruamahunga River diversion can be seen on the left. The natural pre-diversion Ruamahunga River channel to Lake Wairarapa is on the right. The Ruamahunga diversion channels approximately 95% of the Ruamahunga River flow directly to Lake Onoke and the sea. Photograph GWRC

Prior to the construction of the diversion scheme, the Ruamahanga river flowed into and through Lake Wairarapa before entering Lake Onoke. Today, approximately 95 percent of the Ruamahanga River flows go directly to Lake Onoke, bypassing Lake Wairarapa. This is a significant change and, together with the Lake Onoke opening, results in flood flows receding very quickly following a flood event. Pre-scheme, flood waters were present for some weeks. Also, it has helped to keep the mouth opened for a longer period.

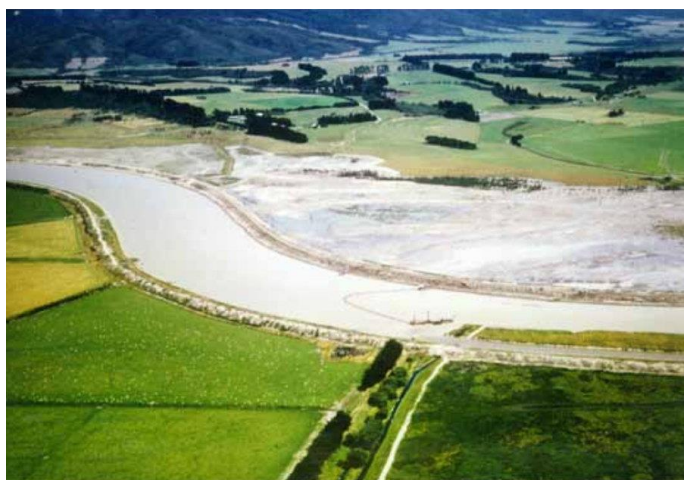
Dredge working on the diversion, 1967. Photograph GWRC

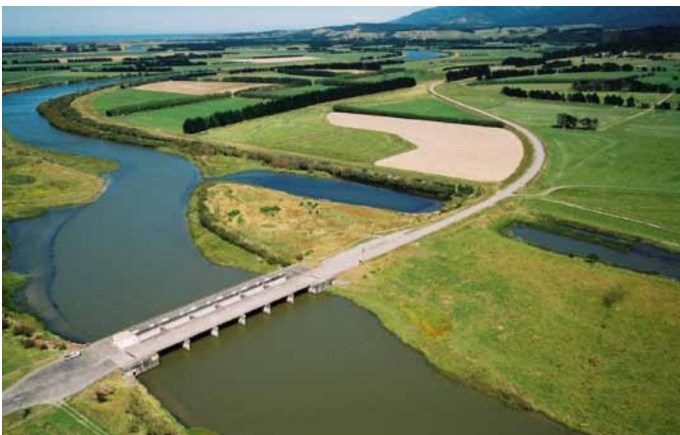
Located on the Papatahi Road (East-West Access) the Geoffrey Blundell Barrage is a structure of six radial-type gates. Each gate is 12.19 metres long, with a maximum clear opening of 4.5 metres.

Barrage radial gates stabilise the water level in Lake Wairarapa to allow sufficient freeboard to accept floodwaters from the Lower Wairarapa valley Development scheme's floodways and tributaries.

The operational regime of the gates is based on a complex interaction of Lake Wairarapa levels, Lake Onoke levels, flow in the Ruamahanga River and current and predicted weather patterns.

The objective is to stabilise the water level in Lake Wairarapa to a defined operating range and to allow sufficient freeboard to accept floodwaters from the Lower Wairarapa Valley Development Scheme floodways and tributaries. The Barrage Gates may be used to either lower or raise the water level in Lake Onoke, or in Lake Wairarapa, depending on the conditions. The seasonal levels at Lake Wairarapa has been determined after years of consultation with the interested parties such as the lake shore landowners, DoC, Fish and Game, the Iwi, LWVDS Advisory Committee, Ducks Unlimited, SWDC and the Regional Council. These levels are stated as “Target Levels” in the Resource Consent issued for the operation of the Barrage Gates, as they are not absolute levels that can be controlled. By and large the weather conditions determine the lake levels.

The Barrage gates are the largest mechanical asset of the Lower Wairarapa Valley Development Scheme. Owing to salty water, the gates need to be regularly repainted and the lifting ropes changed. They are operated mechanically and can be controlled electronically by the Council’s telemetry system.

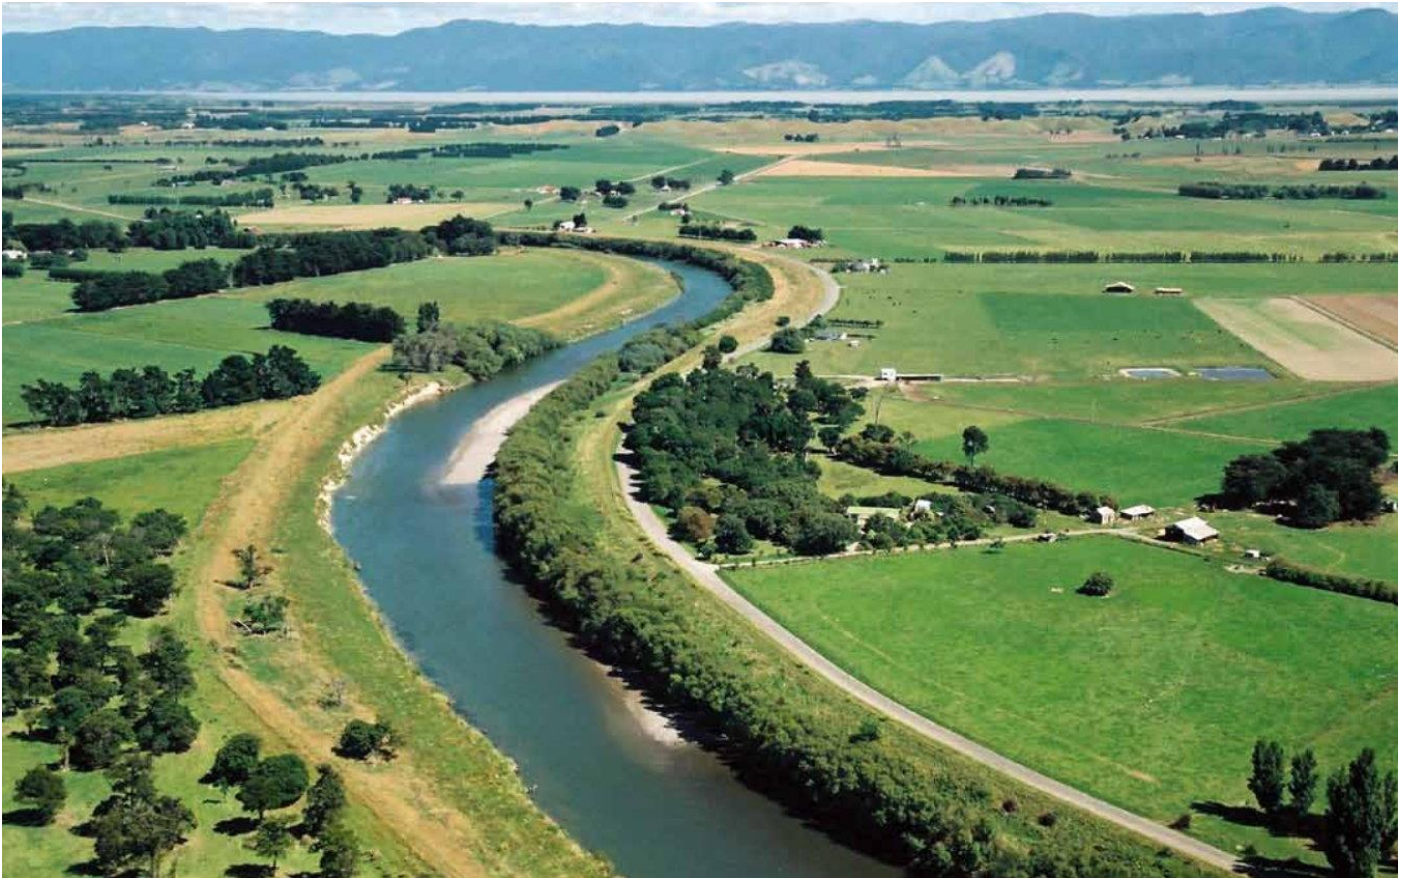
Stopbanks on the Ruamahunga River. Photograph GWRC

On the Ruamahanga River stopbanks have been built from just upstream of Martinborough down to Lake Onoke. Tauherenikau River is stopbanked from SH53 downstream to Lake Wairarapa. The lower reaches of eastern and western tributaries to the Ruamahanga River and Lake Wairarapa are also stopbanked.

Stopbanks between Martinborough and Tuhitarata were designed for 20-year flood standard. This means, there is a 5 percent chance of floods occurring to this level in any one year. The occurrence of floods since the scheme's construction has reduced this to a 10-year flood standard due to the increased frequency of flood events and deposition of gravel and silt. In 2004 a one in 40-year flood occurred and some of the stopbanks were overtopped. Just one pre-scheme stopbank breached during that event.

Short-term overtopping of the stopbanks is not a major problem where they are well maintained, have a good batter slope, a good grass cover and have no stock tracks.

Vegetation, such as willows, but some flaxes and native grasses, are planted on the outside of the stopbanks, on the river berm. The roots of these plantings act as reinforcing to hold up the river edge and their leaves tend to slow down the current. Following extended floods, the berm area can be vulnerable to slumping, which can threaten the edge of the adjacent stopbank. Slumping is where the bank drops away, generally when the floods recede, due to its weight under very wet conditions. Removal of the build-up of silt, and good management of the trees reduce the chance of slumping.
