THE DIVERSION SCHEME

Gates, stopbanks, channels and floodways

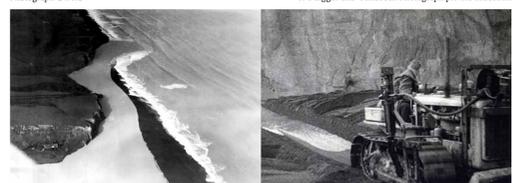
For the first time the mouth of the Ruamahunga River is opened mechanically circa 1940s. Keith McMaster is at the helm. Today, the opening is made using the combination of a digger and bulldozer. Photograph private collection

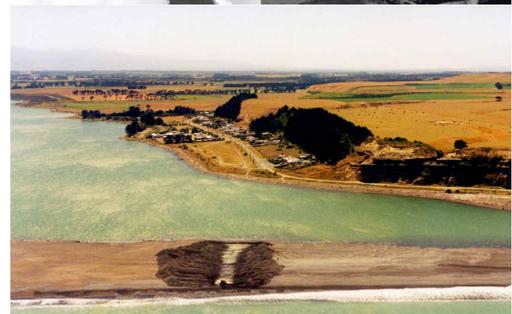
Opening the Ruamahunga River mouth opposite the Lake Ferry Inn (now Lake Ferry Hotel), 1991. Photograph GWRC

The Ruamahunga River flows into the sea at Palliser Bay through the Lake Onoke Spit. The mouth of the Ruamahunga River is called the lake opening. The natural opening generally migrates towards the eastern end of the sand bar and when this happens the flow out to sea is reduced considerably. Under the scheme the opening is sited in line with Lake Ferry road to enable quicker drainage of the river.

Typically, between January and May the mouth gets blocked when there is low river flow, combined with large southerly swells in Palliser Bay. However, it can get blocked at other times, too. In an extreme year, the mouth could be blocked as many as 18 times but on average there are between six and eight blockages a year.

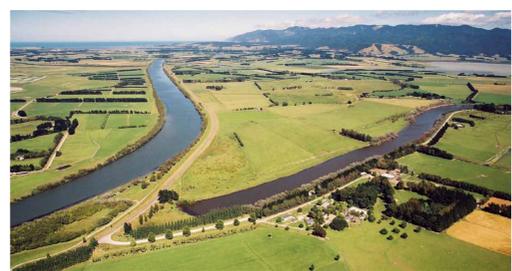
The Ruamahunga River diversion can be seen on the left. The natural pre-diversion Ruamahunga River channel to Lake Wairarapa is on the right. The Ruamahunga diversion channels approximately 95% of the Ruamahunga River flow directly to Lake Onoke and the sea. Photograph GWRC

Prior to the construction of the diversion scheme, the Ruamahunga river flowed into and through Lake Wairarapa before entering Lake Onoke. Today, approximately 95 percent of the Ruamahunga River flows go directly to Lake Onoke, bypassing Lake Wairarapa. This is a significant change and, together with the Lake Onoke opening, results in flood flows receding very quickly following a flood event. Pre-scheme, flood waters were present for some weeks. Also it has helped to keep the mouth opened for a longer period.

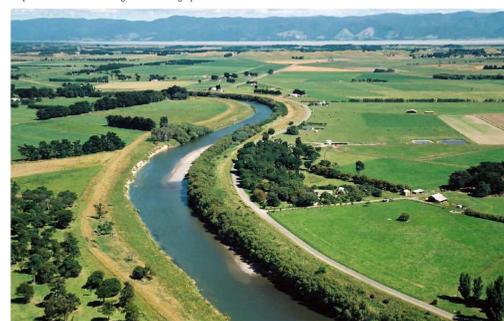
Stopbanks on the Ruamahunga River. Photograph GWRC

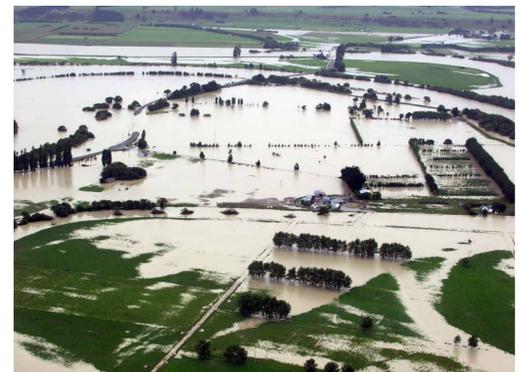
Flooding over State Highway 51, Martinborough, 2004. Photograph GWRC

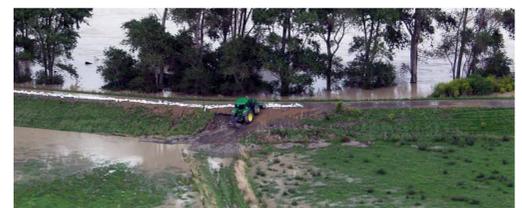
Sandbags add extra protection on Ruamahunga River stopbanks, 2004. Photograph GWRC

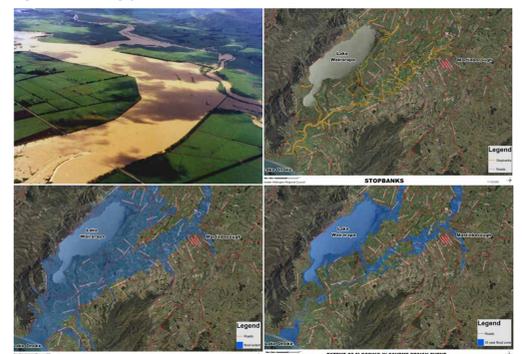
The Oporua floodway working in 2000. The Ruamahunga River (top right) is feeding the floodway. The Kahutara to Pirinoa road is diagonal bottom left. Photograph GWRC

At Oporua, extensive works have been constructed to reduce scouring of Kahutara Road and the channel through the floodway. Great care is needed to maintain this area to prevent the scouring of the floodway upstream. The Kahutara Road is closed when the Oporua floodway is working.
